GULFCO MARINE MAINTENANCE FREEPORT, BRAZORIA COUNTY, TEXAS

DETECTED CONCENTRATIONS
EXCEEDING ECOLOGICAL
SCREENING LEVELS - INTRACOASTAL
WATERWAY SEDIMENT

DETECTED CONCENTRATIONS EXCEEDING ECOLOGICAL SCREENING LEVELS - PONDS SEDIMENT

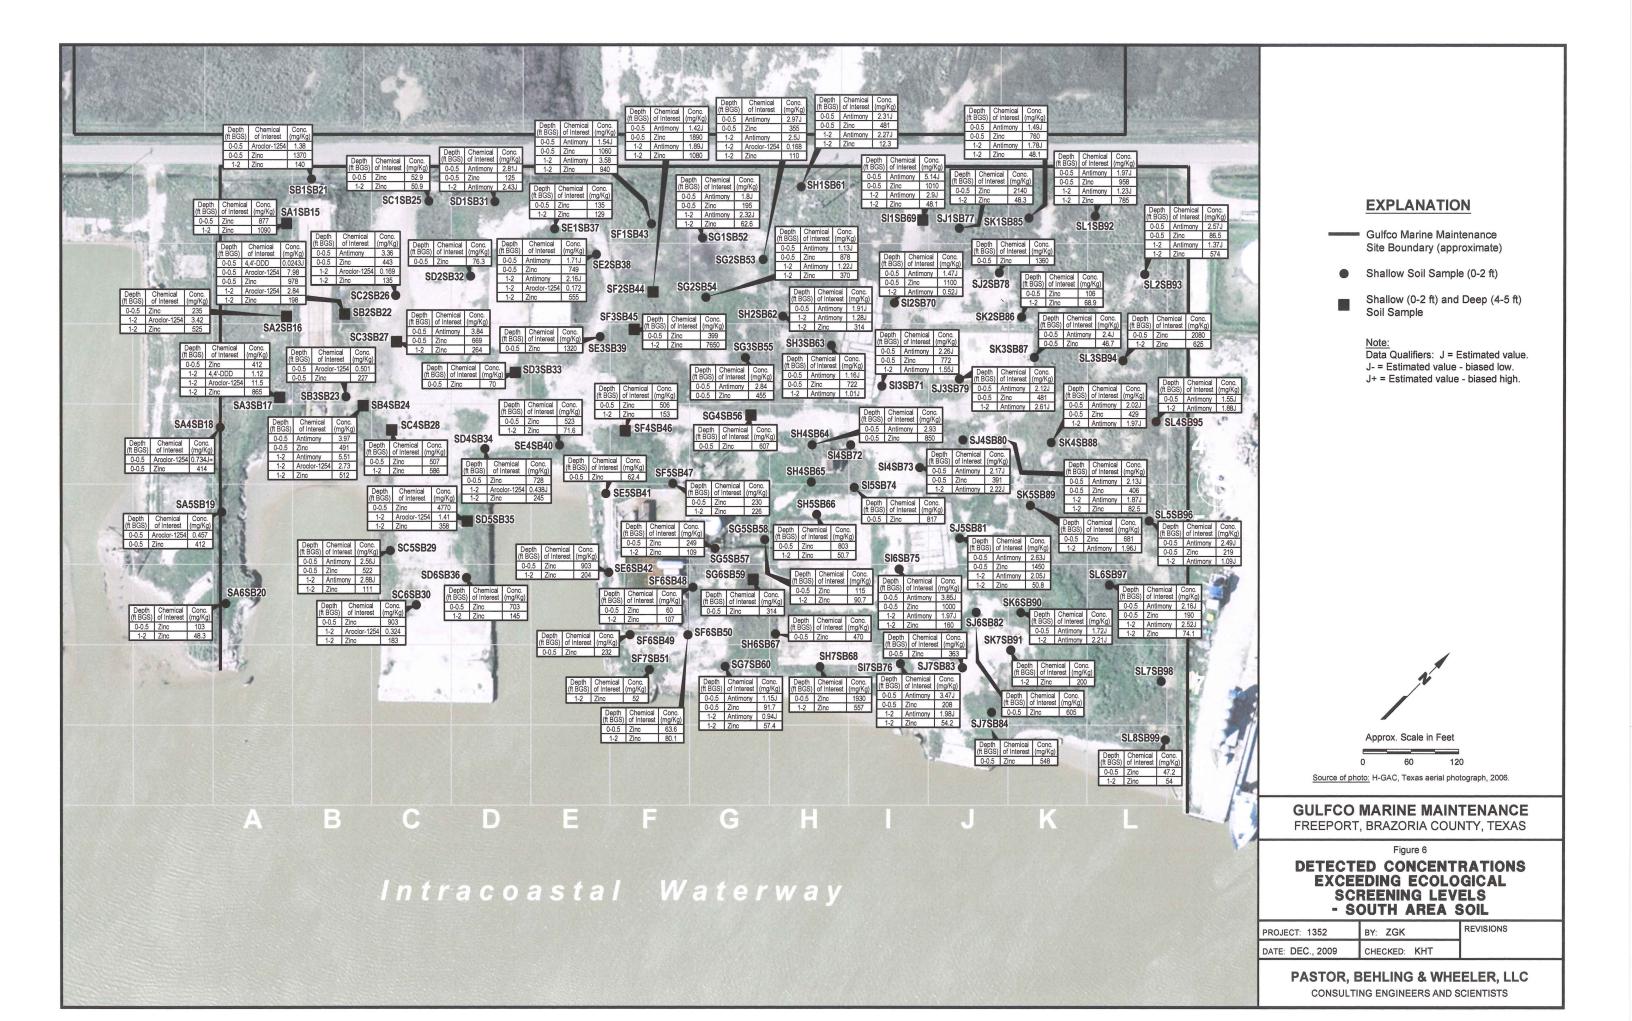
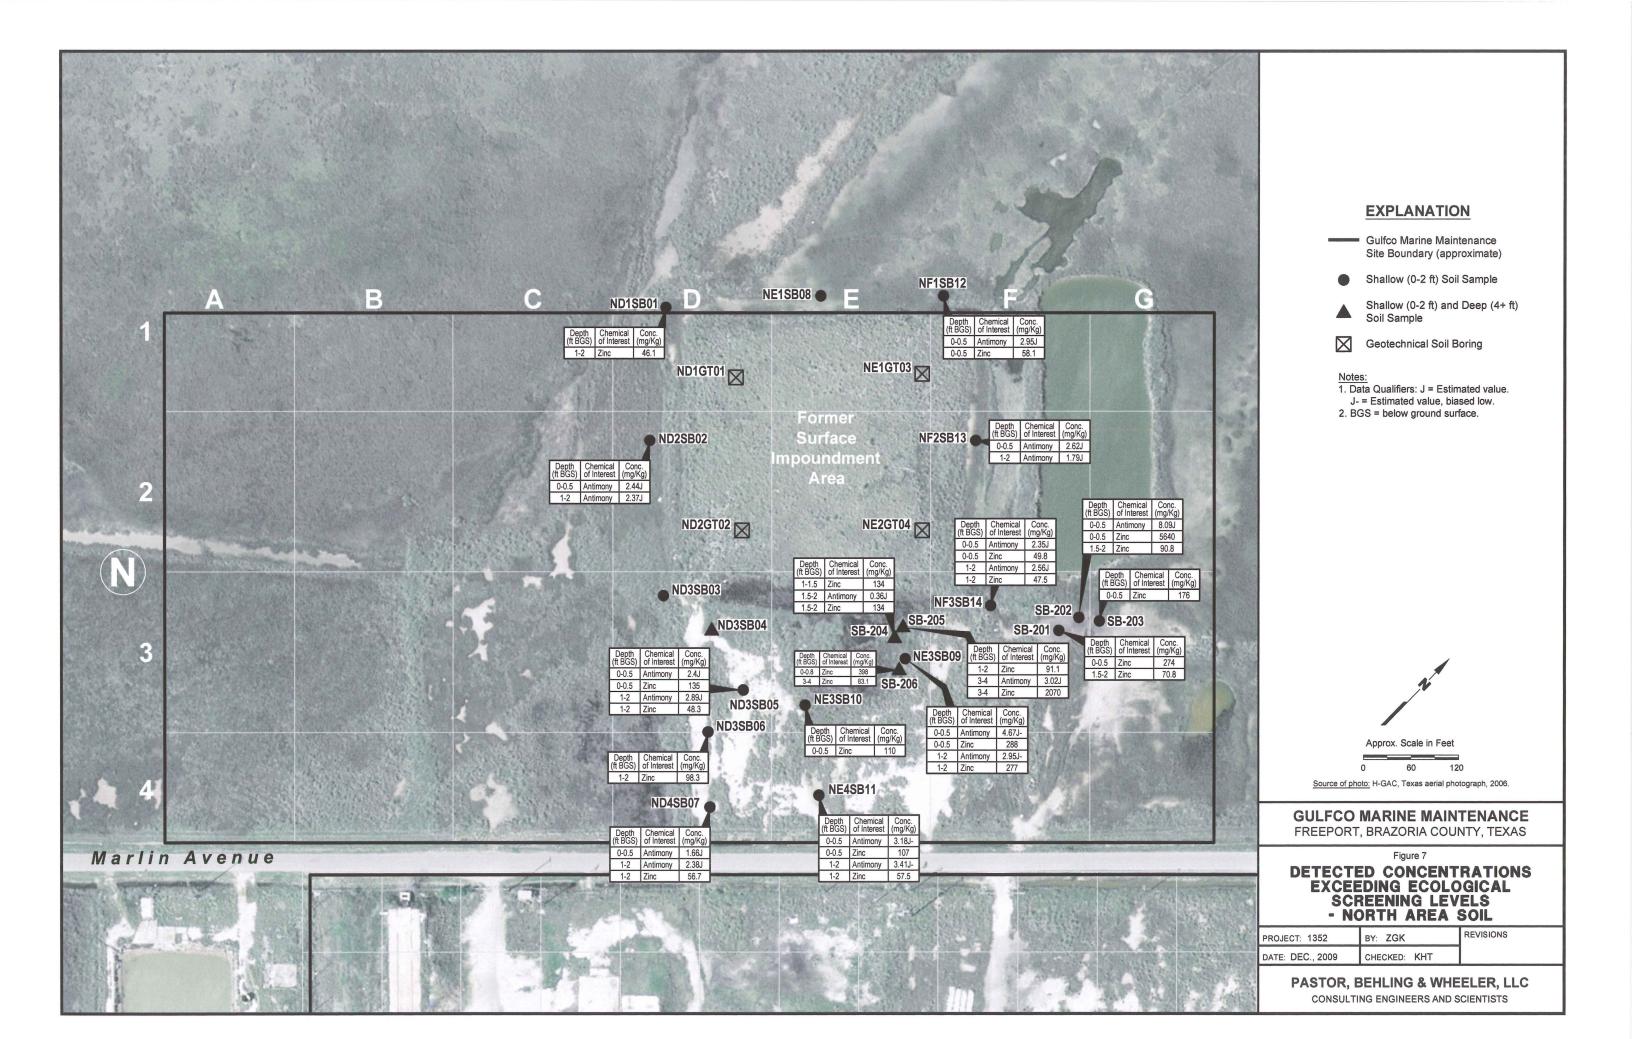
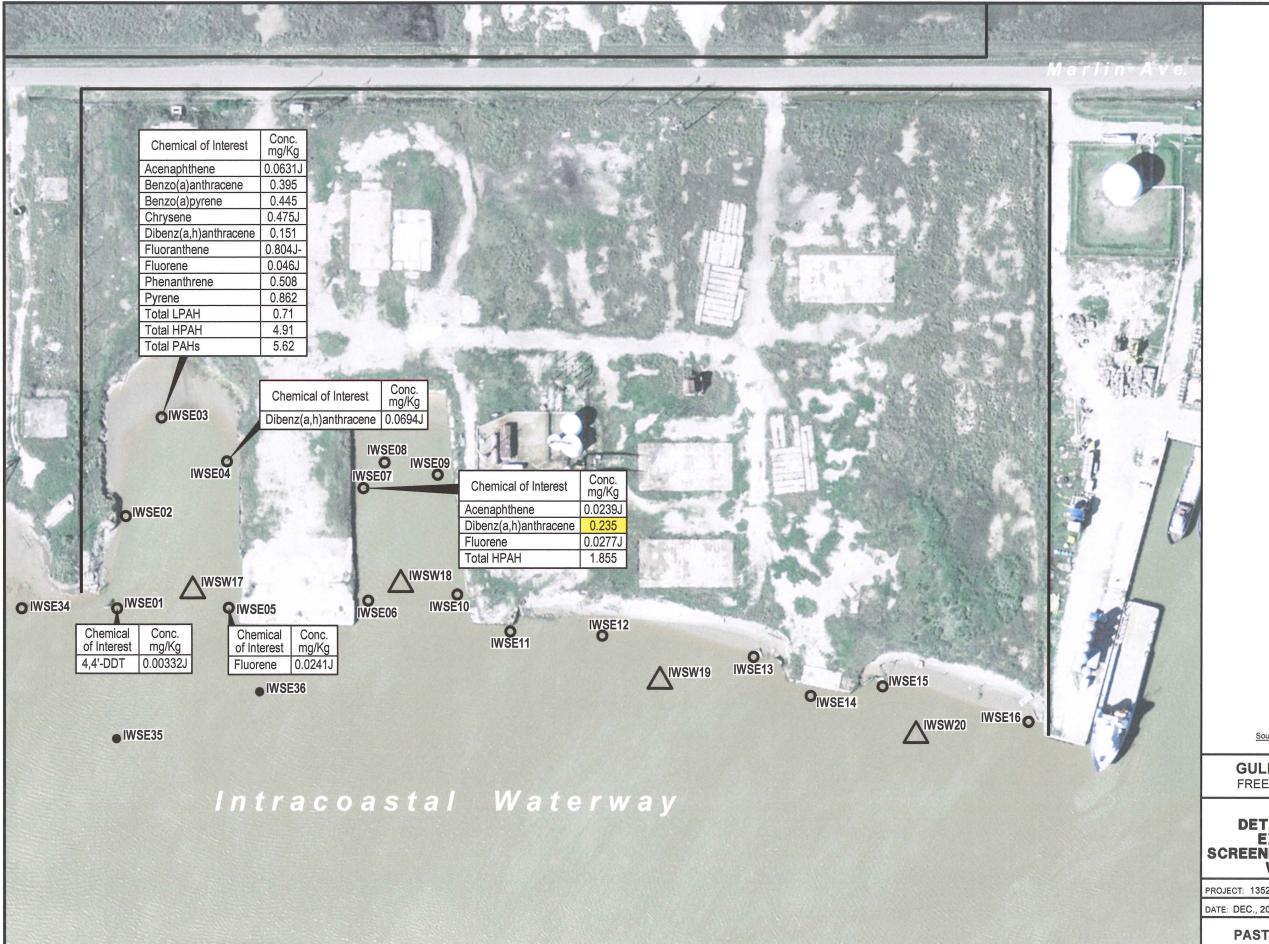
Figure 9

- Total PAH concentrations were calculated using ½ of the sample detection limit as a proxy value for undetected PAHs.
- Highlighted values exceed the midpoint of the TCEQ PCL and SEL; all other values listed in figure exceed the screening level.

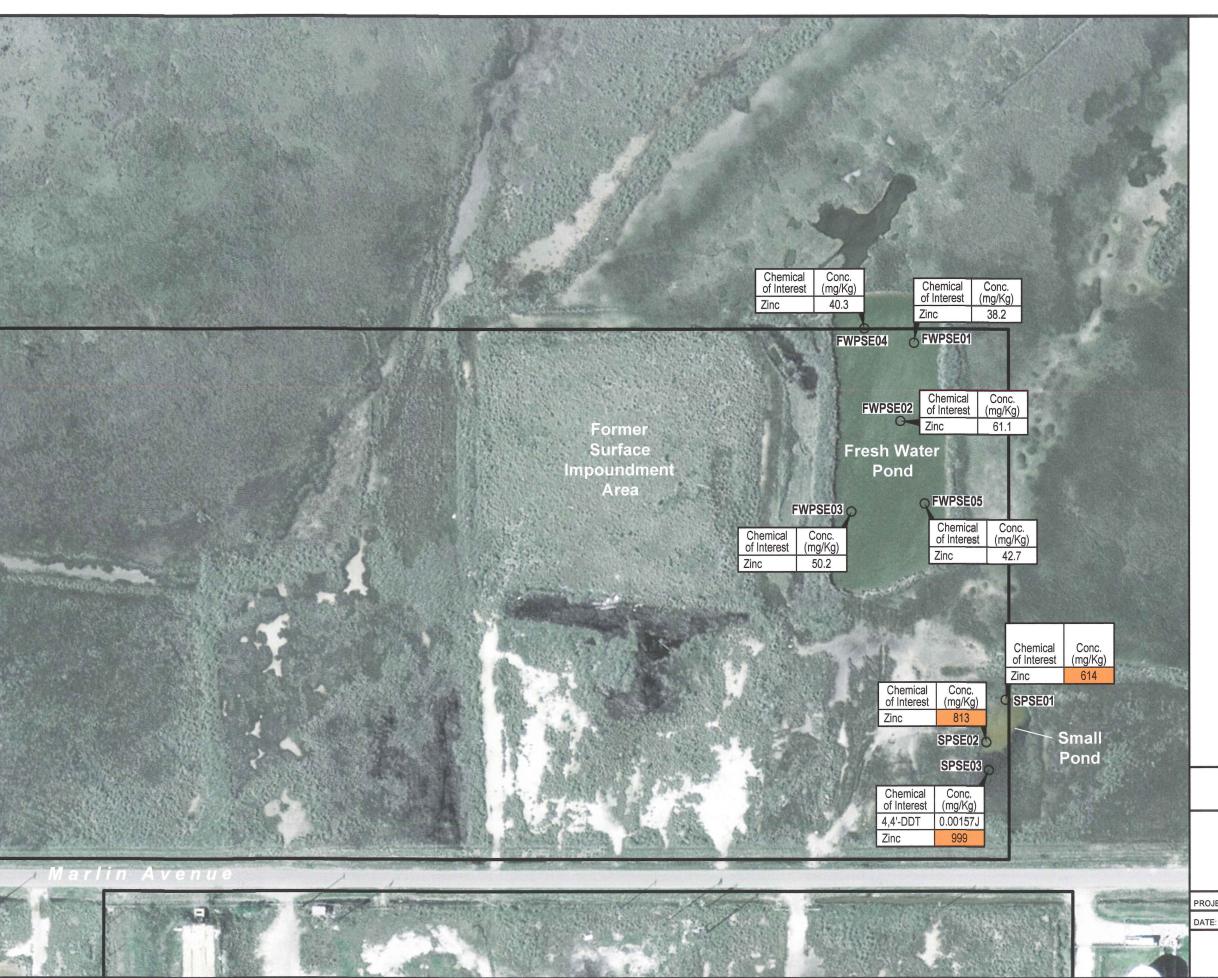
Figure 12

1. All samples from 0-0.5 ft depth interval.
- 2. Data Qualifiers: J = Estimated value.
- Highlighted yellow values exceed the midpoint of the TCEQ PCL and SEL; all other values listed in figure exceed the screening level. Highlighted orange values exceed the ERM.
